TECHNICAL REPORT REMR-CO-4

STABILITY OF DOLOS AND TRIBAR OVERLAYS
FOR REHABILITATION OF STONE-ARMORED
RUBBLE-MOUND BREAKWATER AND JETTY
TRUNKS SUBJECTED TO BREAKING WAVES

Robert D. Carver, Brenda J. Wright

February 1988

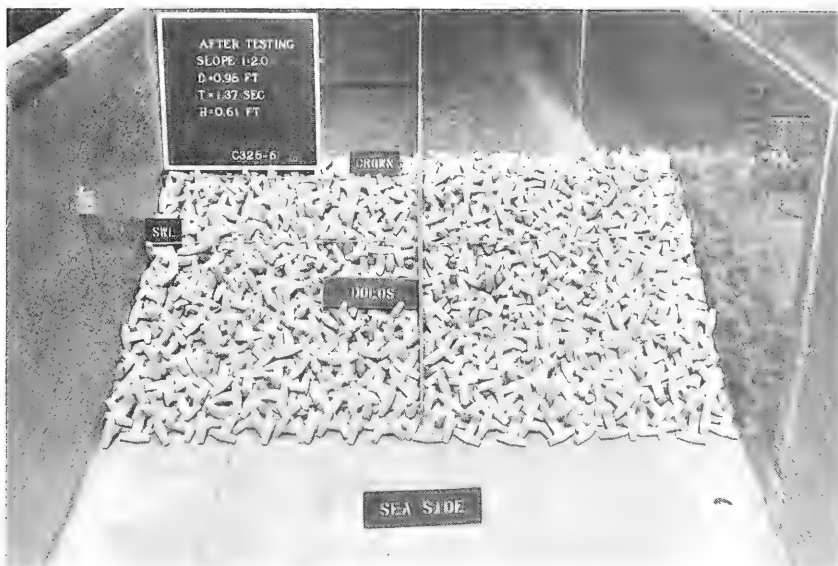
Photo 5. Sea-side view after attack of 1.37-sec, 0.61-ft waves; $d = 0.95$ ft; $W_a = 0.276$ lb; 1V-on-2H structure slope; dolos armor

Armor units were placed randomly in two layers and the number of armor units per given surface area was equal to that presently recommended for new construction in EM 1110-2-2904, "Design of Breakwaters and Jetties" (Headquarters, Department of the Army 1986). Photos 4-10 show typical after-testing conditions of structures.

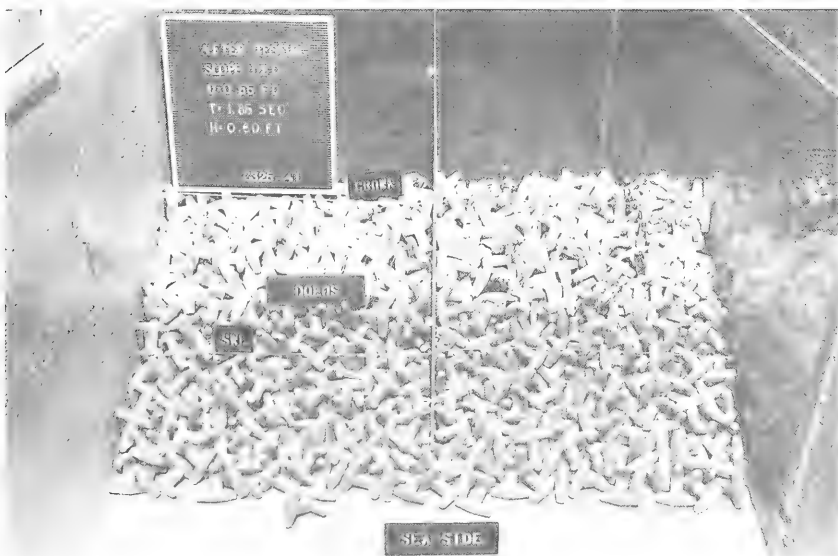
Photo 6. Sea-side view after attack of 1.85-sec, 0.60-ft waves; $d = 0.65$ ft; $W_a = 0.589$ lb; 1V-on-2H structure slope; dolos armor

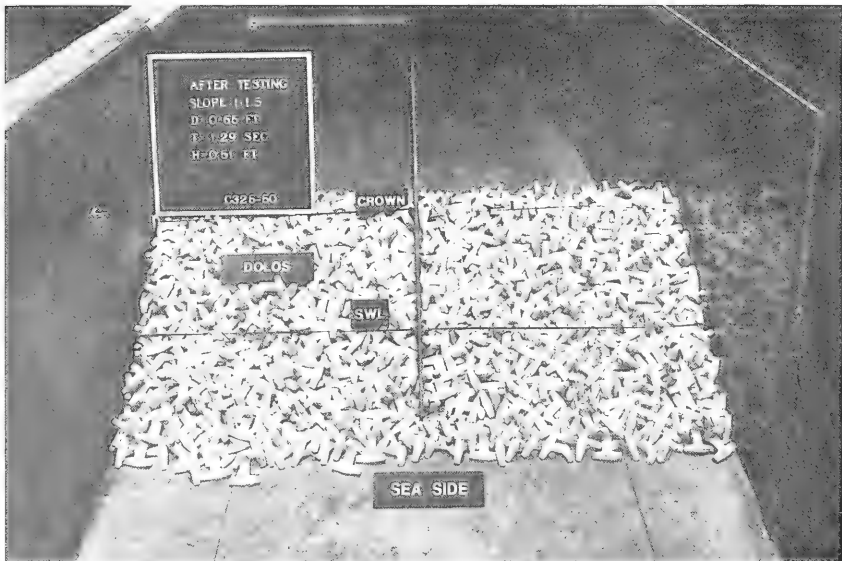
Photo 12. Sea-side view after attack of 1.29-sec, 0.51-ft waves; $d = 0.65$ ft; $W_a = 0.276$ lb; 1V-on-1.5H structure slope; dolos armor

in Table 2 and depicted in Photos 11-14, were similar to those obtained at the 1V-on-2H slope. However, a slight decrease in stability was observed.
